70,000,000 litres of rain water – should they be wasted?

The question is can something be done to existing abandoned reservoirs? How about restoring the Has-Saptan Reservoir limits of Birżebbugia?

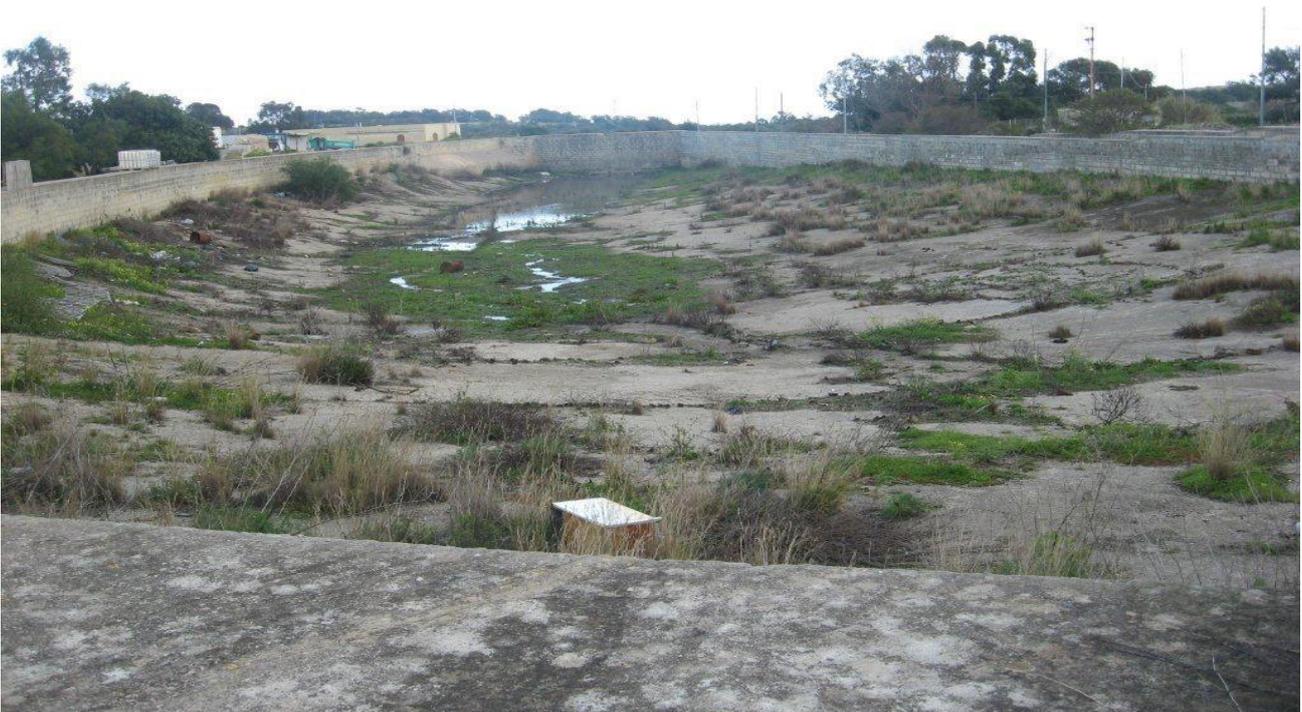
This reservoir was built in 1977 when the new runway was constructed. Its purpose is to collect the rainwater that falls on this runway. This reservoir has a capacity of 70,000m³. From information provided by Eng. Marco Cremona, this reservoir loses water through leakages therefore it is not in use anymore.

He surveyed the reservoir's condition in winter of 2006. After 48 hours of heavy rainfall, practically no water remained in the reservoir. The small amount of water not totally wasted is that which seeps into the ground which recharges the aquifer. The rest runs rapidly down the valley ending in the sea in Birżebbugia.

The situation from 2006 till today seems to have worsened. After 60.8mm rainfall registered by the Met Office, between 19th and 28th February 2011, the reservoir emptied in less than 24 hours as this photo taken by ourselves on the 29th February shows.

All this water can be used for irrigation of green areas, cleaning of roads in dry seasons or offered to the Malta International Airport for its landscaping.
